# Lessons learned by causing a false AIS MOB alert

... written for XXXXX by XXXXXXXXXX and posted on Aug 8, 2017

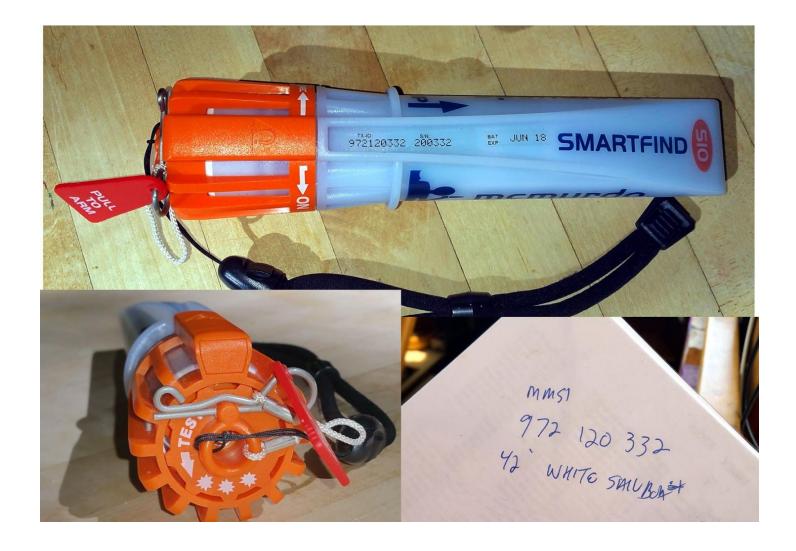
"Geez, I've got four of those onboard," I added, heading forward to grab the ditch bag I'd recently used to organize the various safety devices being long tested. I certainly did not expect any of the beacons to be activated, but when I pulled the <a href="McMurdo FastFind S10">McMurdo FastFind S10</a> out of that big EPIRB pocket, its white translucent end was flashing. It was obviously on, and it was great to find easily-understood Off instructions once the black neoprene cap was pulled back. That's when the Coasties started grinning.

Petty Officer laci and Fireman Jansen-Hedrick also got the satisfaction of seeing the S10's preprogrammed MMSI match up with the one they were looking for. Mission accomplished! And I, too, was happy to head back to my mooring, though that's where my embarrassment was compounded by learning that the USCG had tried to contact me by cellphone and even by Facebook. I had some explaining to do, at least to myself.

Note the S10's hand-grenade-like Pull-To-Arm pin above. In fact, this AIS beacon is especially designed for divers who might get separated from their mother vessel. You could activate it while wearing heavy gloves, even mitts, but not accidentally. The spring-loaded orange top easily twists 90 degrees counterclockwise to turn the device OFF (or test it), but it won't budge clockwise to ON unless the pin is pulled. And it's *never* been pulled.

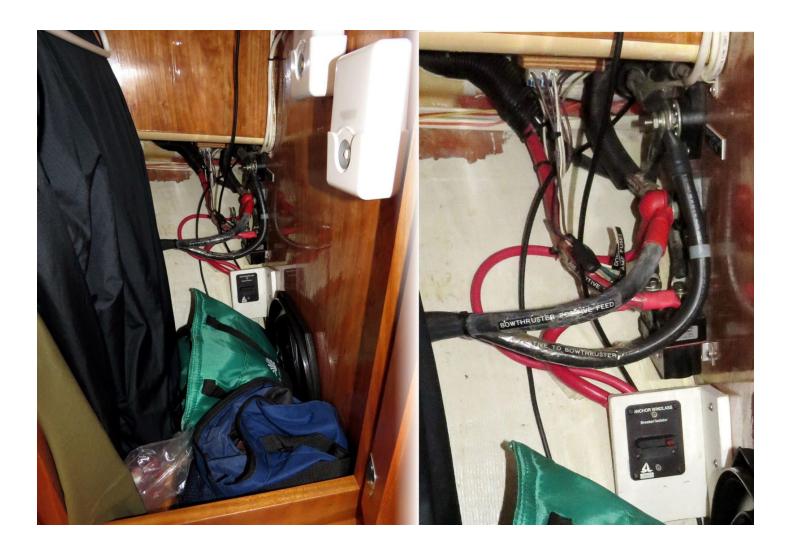
Yup, a couple of weeks ago I stuffed the ditch bag into this forward starboard hanging locker, with the EPIRB pocket up close to those high current bow thruster and windlass cables, as well as the 100 amp circuit breaker. In retrospect I vaguely knew that electromagnetism was possible around such serious 12v power flow -- it's <u>Lenz's Law</u>, according to <u>Alden</u> -- but could there have been enough focused magnetic field to activate the S10?

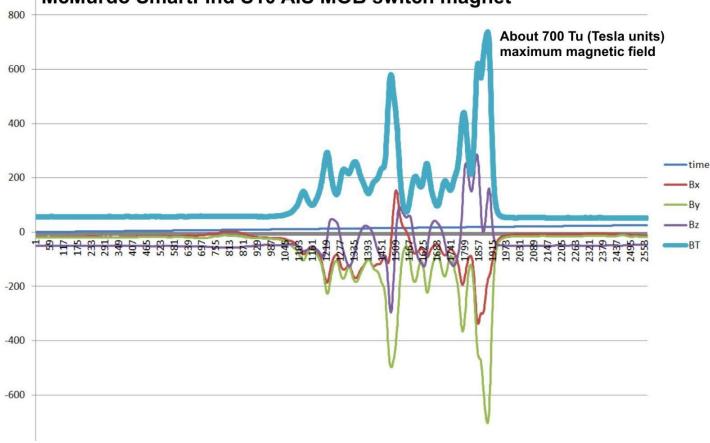
So here's what my new magnetometer saw when I waved the top of the phone an inch or so from the magnet area of the McMurdo S10 beacon. In other words, that's the approximate magnetic force that will turn the S10 on if the pin is pulled and the orange top is turned 90 degrees clockwise so the magnet is over the <u>reed switch</u>. Incidentally, I also learned that I could activate the S10 by direct application of a <u>fairly modest magnet</u> to the right spot (in my basement, and very rapidly turned OFF).

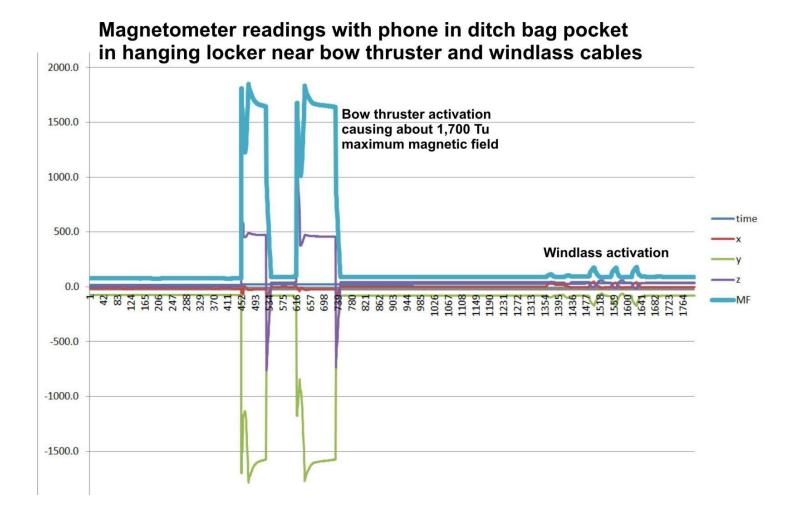
Now here's what happened magnetically when I put the phone in the ditch bag back in the locker and then ran the thruster and windlass intermittently. My inadvertent mission accomplished? Well, that's certainly a relatively significant magnetic burst -- about 2.5 times what I measured from the S10's magnet -- and I had used the thruster briefly getting off the ramp dock, but that timing did not jibe with what I learned from the USCG command center at Sector Northern New England in South Portland.

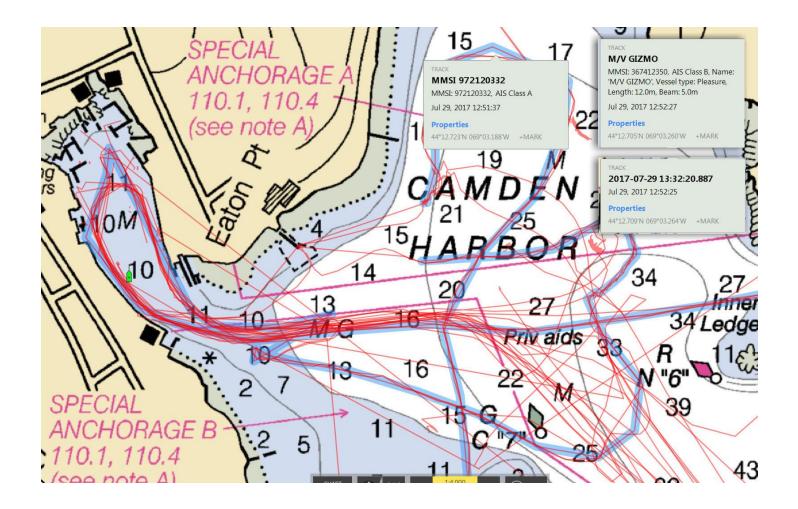
Then I remembered the YDVR log, which led to theory refinement and confirmation. The recorder is on the boat's secondary N2K network, and it not only captured *Gizmo's* own AIS track being received by the Icom M605, but also the boat's high resolution GPS track and the AIS track of the S10 beacon. That 972 MMSI track starts just after I left the ramp dock shortly before 10am -- thruster activation confirmed -- and ends at the USCG rendezvous.

But the 972 track is also quite consistent over those three hours, indicating that the S10 did have a GPS lock and was transmitting regularly despite its location. I do think that the transmissions were quite muffled -- otherwise other boats and the USCG would have been on the case sooner and harder -- but the S10 performed pretty darn well in this unplanned test.

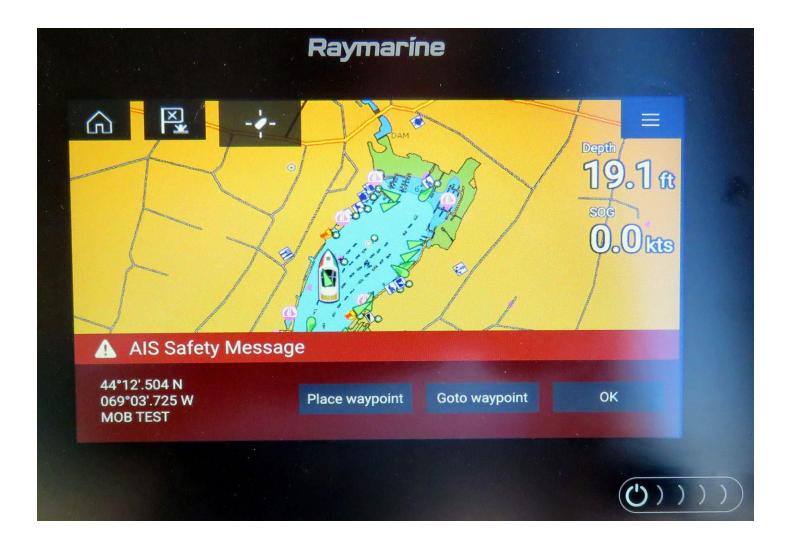
After all, the prime function of an AIS MOB beacon is to alert the boat that it was on before activation, and freaky *Gizmo* had two AIS receivers and many AIS plotters turned on that day. Plus, as McMurdo justifiably pointed out, one benefit of its <u>new G8 EPIRB with AIS locator</u> is that it could quickly help a boater deal with an accidental activation.

Part one of my answer is easy. Sometimes the always-on Vesper XB8000 AIS transponder does not join *Gizmo's* main N2K network when it's turned on. I think the behavior is fairly peculiar to this network, and I noticed the lack of targets on the three flybridge MFDs it feeds right away, but I didn't bother to go below and reboot the XB. I could see all the boats fine, anyway, and there was lots of enjoyable socializing going on.

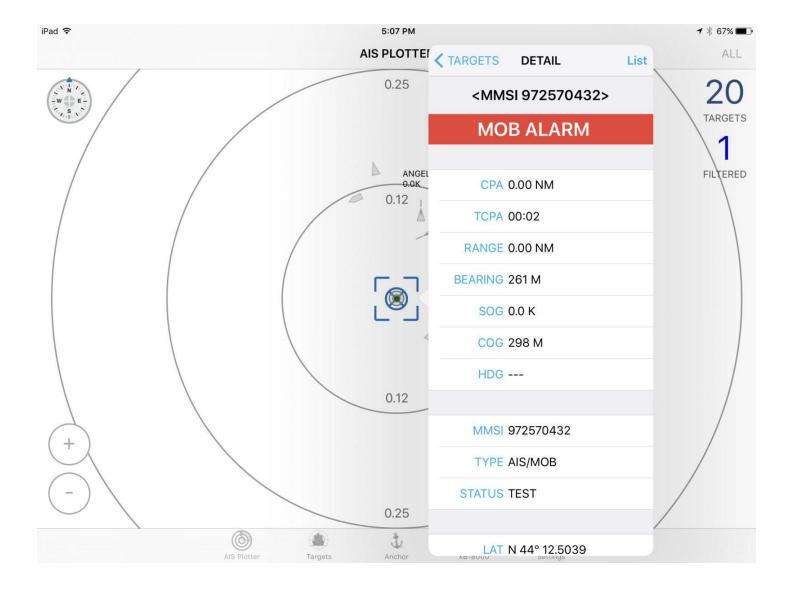
The beautiful day in very familiar waters, the events, and the friends were all part of the bigger distraction issue, but part two of the answer truly makes me cringe. In retrospect, I'm quite sure that I did get an AIS MOB alert, a very loud one, but I shut it down without looking at what it was!

Recall my recent <u>first look at Vesper's brilliant new smartAIS alarming</u>. I'm so not used to its features that when a loud siren went off shortly after I thrusted *Gizmo* off the ramp dock, my first guess was the <u>Maretron ALM100s</u>, the only alarm system I've encouraged on this potentially way-over-alarmed vessel (until the compelling Vesper update). But there was no sign of alarm on the Maretron displays, and it kept wailing away even when I briefly switched off the N2K network. And, mind you, I was maneuvering through a large field of moored yachts from the diminished visibility of the lower helm, while six fresh crew were getting settled or looking over my shoulder for the source of the annoyance.

Finally, I remembered the new Vesper features and had to scramble to open the <u>WatchMate app</u> on the iPad (because I have not yet installed the physical switch I had just recommended). I presumed that it was either an AIS or an anchor drag alarm -- both of which I had recently fooled with -- and went right to the app page where I could mute the siren. But the Vesper XB8000 can also alarm on an AIS MOB message, again even with the app unopened, and I believe I proved that it is almost foolproof!

**So many lessons learned.** Hopefully, a lot are already obvious, as I've gone on enough, but among the so-far-unmentioned mistakes: I should have had another VHF constantly on channel 16 up on the flybridge, since I often had the Icom CommandMic on the channel used by the parade or race organizers; I should have more than a draft getting-underway checklist of items like rebooting the Vesper (until that glitch is solved); and I should remember that the <a href="high-incidence-of-accidents-close-to-home">high-incidence-of-accidents-close-to-home</a> is a real thing. Feel free to add others or compose a list.
