A Quest for Keel Integrity

Recent tragedies at sea highlight structural shortfalls.

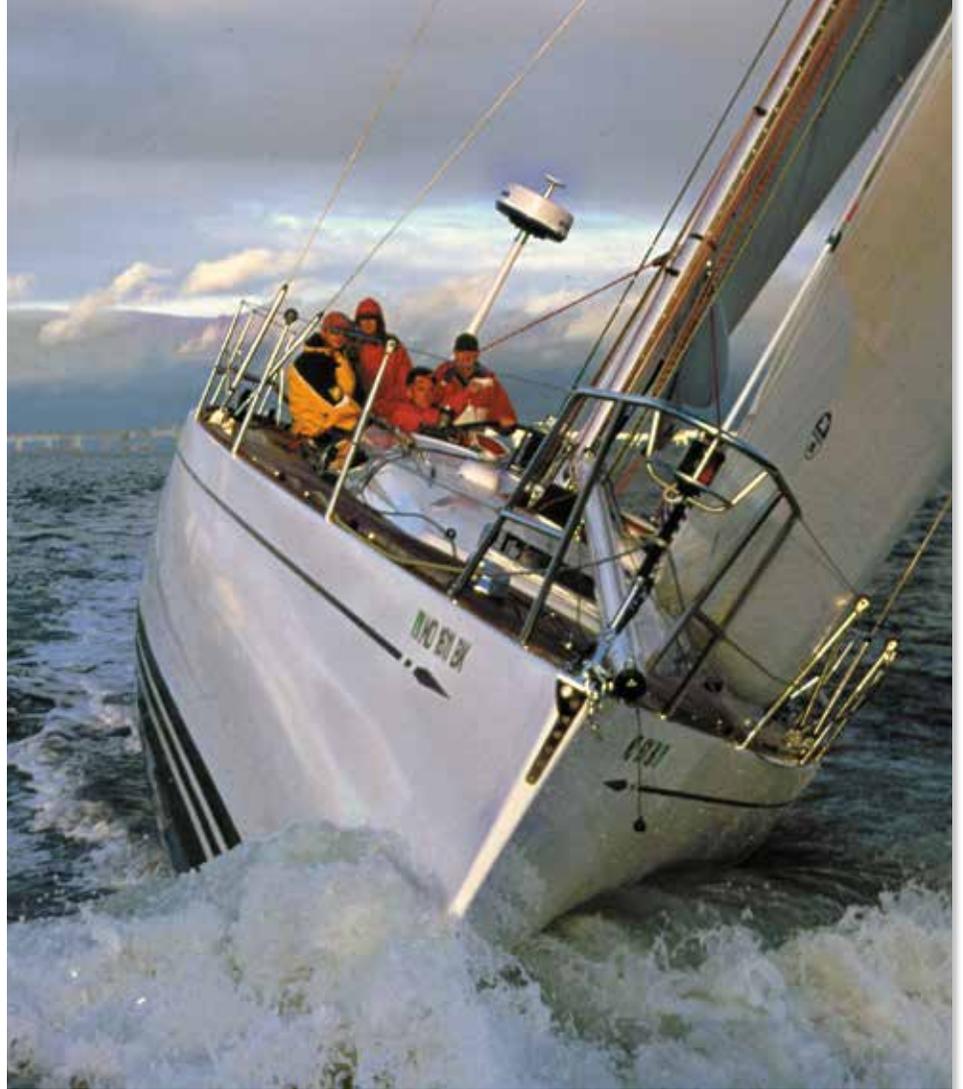
When righting moment opposes heel, forces are focused at the keel-to-hull junction. While modern boats withstand sailing loads, a grounding can cause invisible harm.

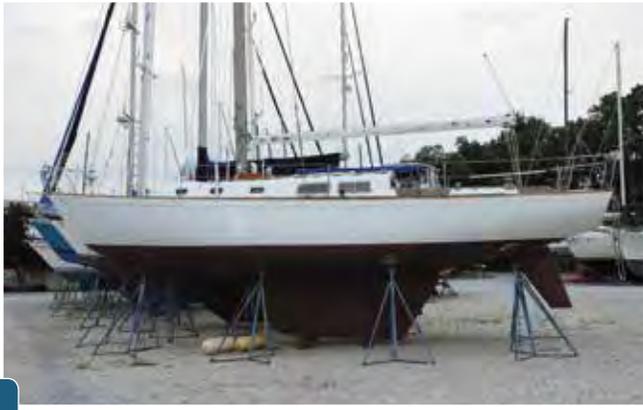
1

1. The Cal 40 is a classic example of an early fin-keel design with internal lead ballast.
2. *Puffin* is a classic, 47-foot, wooden Sparkman & Stephens yawl with supported external lead ballast and silicone bronze keel bolts.

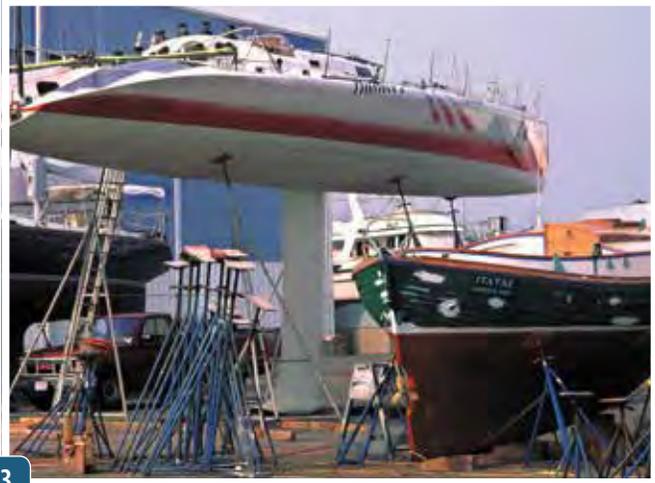
3

3. The two extremes of keel design are reflected in *Hunter's Child's* bulb and foil ballast and *Itatae's* full-length, timber keel with internal lead ballast.

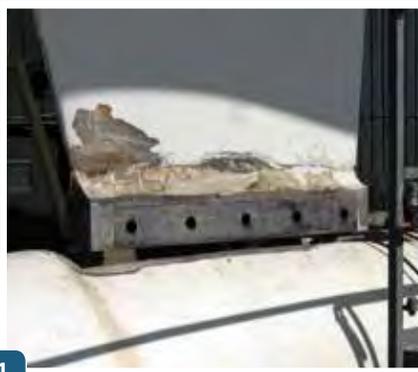
1

1. The thick, stainless-steel fin is slotted into a lead ballast bulb. Transverse bolts will lock the tenon-and-mortise joint, and a high-strength epoxy will be used to ensure a tight fit at the junction.

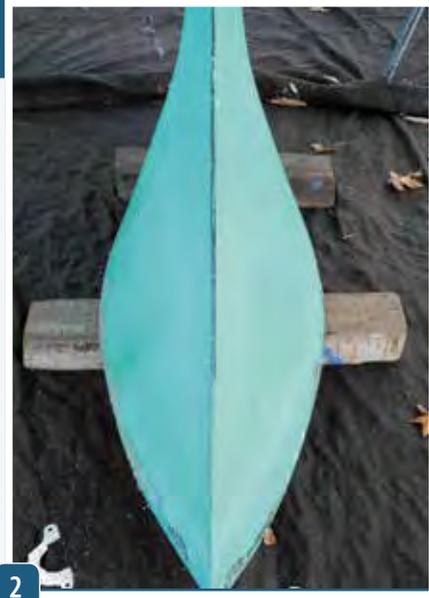
2

2. Casting a lead/antimony, contiguous ballast keel with anvil eliminates the need for a fin-to-bulb connection.

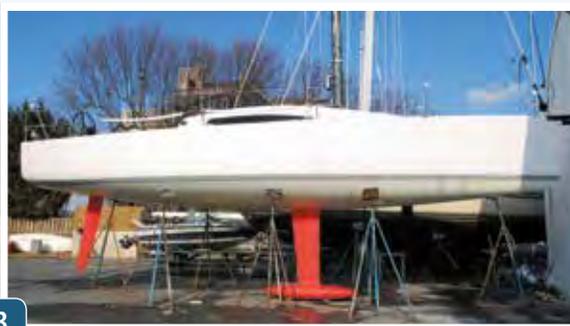
3

3. The larger the bulb and the finer the keel foil, the more load is placed on the fin-to-bulb junction.

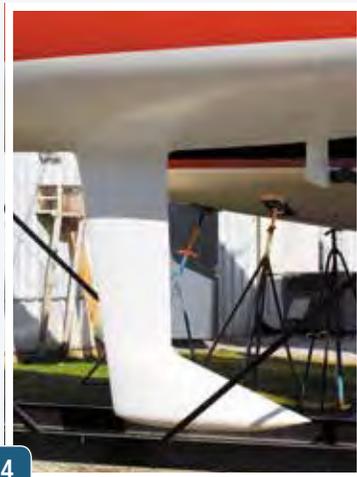
4

4. Large surface area, heavy, tip-of-the-

keel ballast packages can be problematic in a grounding. If a tow boat attempts to spin the bow, keel damage may occur at the keel-to-hull interface.

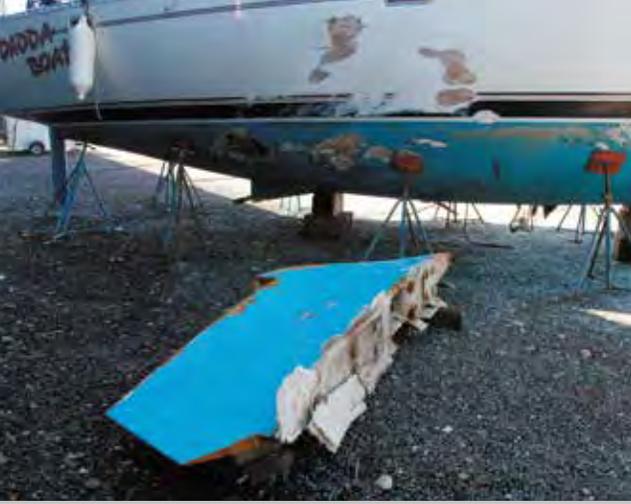
When a ballast keel tears from the hull skin with all mechanical fasteners intact, as occurred when this Beneteau fetched up on rocks, it is clear that the weak link was the hull laminate schedule rather than the keel bolts.

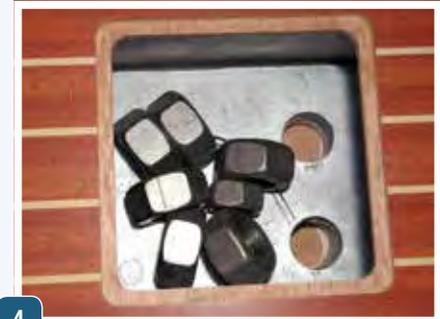
4

4. Nuts should press down on thick backing plates. Galvanized, mild-steel plates are acceptable, but using non-ferrous metal for keel bolts and nuts is recommended.

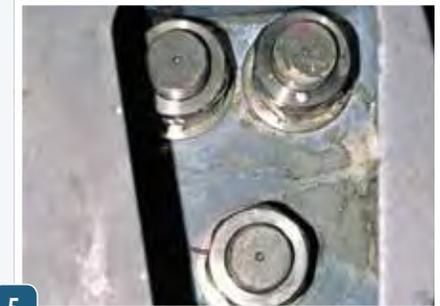
5

5. Some builders use steel weldments to spread loads at the keel bolts. These should be tapered, or extra laminate should be added to prevent stress risers where the metal ends.

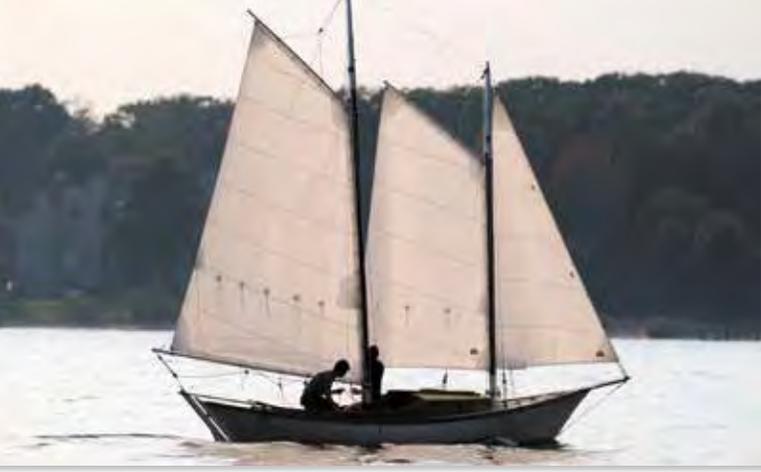
A traditional, gaff-rigged schooner may have either internal or external ballast spread along its shoal-draft, full keel. Such a low aspect ratio keel is often more forgiving in a grounding.

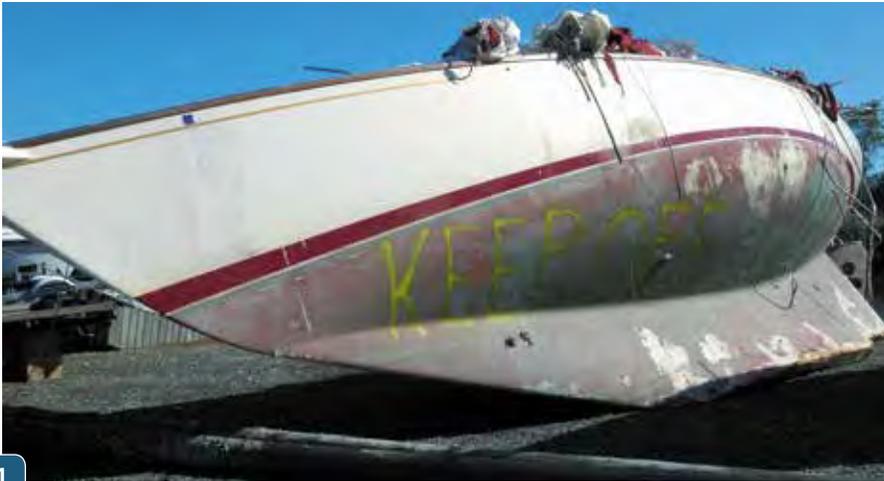
1

1. Despite the severe damage to this storm-ravaged Alden 44, the long keel-to-hull joint remains intact. 2. The anvil bulb on a moderate-draft fin keel will absorb some impact in a hard grounding, but it still should be carefully surveyed after the grounding, and after any structural repairs. 3. Rust on an iron keel can be cosmetic or a sign that bolts are failing; in either case, the cause of the problem should be found.
