# Lessons learned by causing a false AIS MOB alert

... written for XXXXX by XXXXXXXXXX and posted on Aug 8, 2017

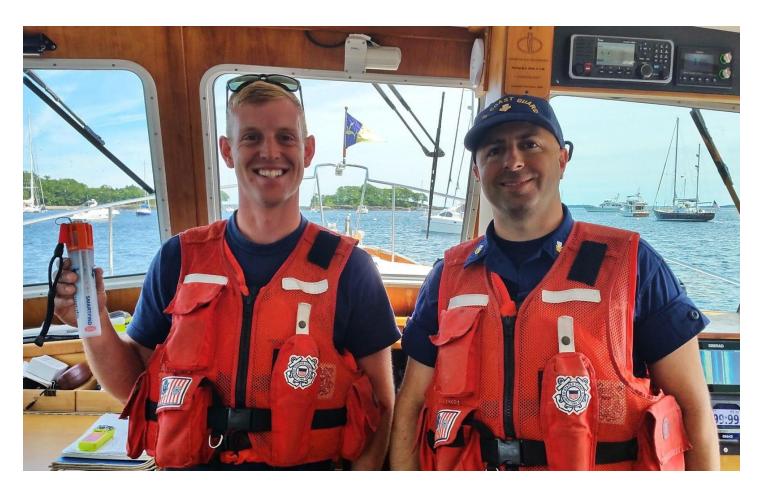
The grins tell the story: Mission accomplished! Due to an obscure but noteworthy electrical glitch, plus oodles of embarrassingly distracted seamanship on my part, a sizable U.S. Coast Guard team spent part of a beautiful Saturday looking for an AIS man overboard alert that seemed to be associated with my boat *Gizmo*. Fireman Joey Jansen-Hedrick and Petty Officer 1st Class T.J. laci (above) were the boarding party that had to deal with an owner/operator (me) who was pretty sure they didn't know what they were talking about. But they were politely persistent, and they were right...
