# New and cool underfoot

## Tired, sole-scorching teak decking gets the heave-ho

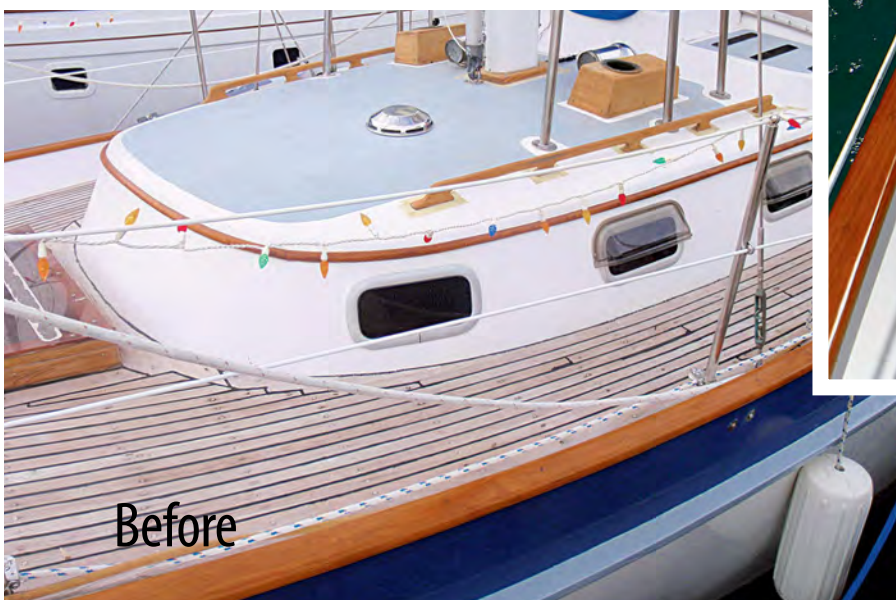
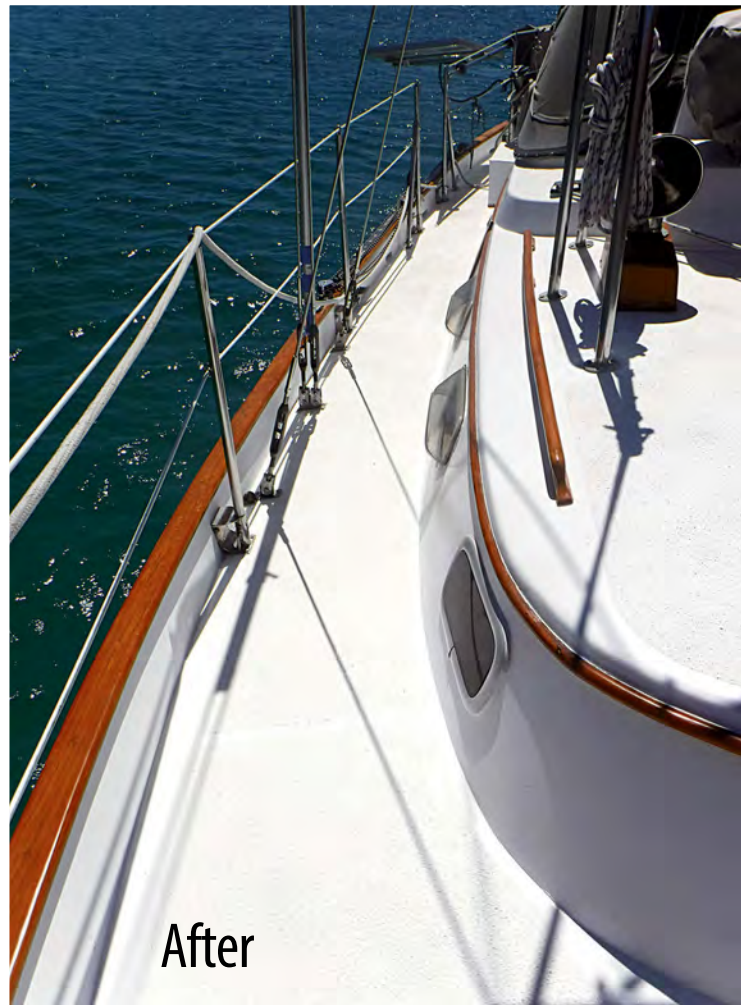
**Teak decks are handsome and have great non-skid properties, top left, but it was time on *Cetus* to remove the teak and paint the underlying fiberglass, top right.**

*Cetus* and crew had recently returned from the high humidity of the South Pacific to the relative dryness of Mexico’s Sea of Cortez. Before long, the teak decks started to show signs of shrinking and cracking, and the caulking was pulling away from the individual planks. I was at a crossroads: do we continue to put the time into repairing the old teak decks or do we take them off entirely?

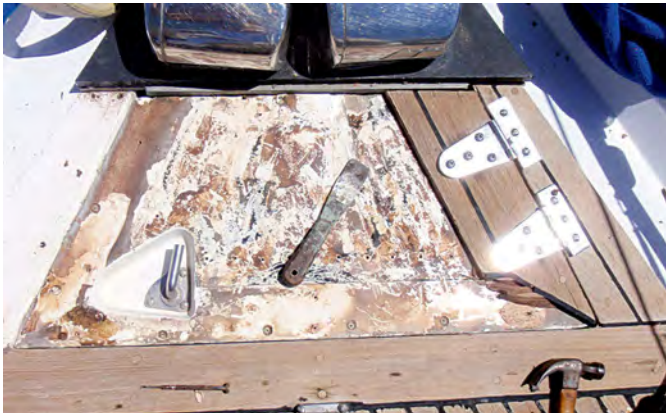
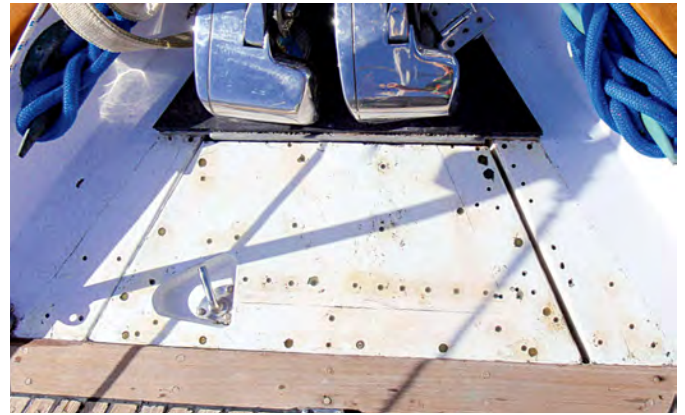
The anchor locker hatch offered an opportunity to test the feasibility of removing the teak decking, above left. The fiberglass deck under the teak was sound enough to stand alone, above right. [redacted] first step in the main project was to cut around the screws, below.

While pondering the pros and cons of removing the teak, I realized I could experiment with a small section to see what I was up against. The anchor locker hatch seemed the perfect place to do that. Not only is it small, just 1 foot by 2, it is separate from the rest of the deck. If I found hidden surprises lurking below that teak, I could stop there and the rest of the deck would remain intact.

of which were the longer fasteners that made up the majority of screws securing the teak to the main deck. After I'd carefully removed the bungs and the short screws, I was able to pry the teak strips right up with the help of a large screwdriver. Underneath, I found a light coating of white bedding compound that came up easily with a putty knife. This was a far cry from the horror stories we'd heard of the thick black tar-like material used to bed teak decks on many other boats built in Taiwan.

My next step on the hatch was to drill out the screw holes, using a bit that was  $\frac{1}{16}$  inch larger in diameter than the screws I'd removed. I made sure not to drill deeper than the original depth.

I used a bevel drill bit to widen the tops of the holes for better epoxy adhesion, and blew out the dust and debris with compressed air from a can. After wiping down the top of the hatch with acetone, I injected thickened epoxy into the holes. Once the epoxy set, I sanded off the excess and removed the rest of the bedding material from the hatch

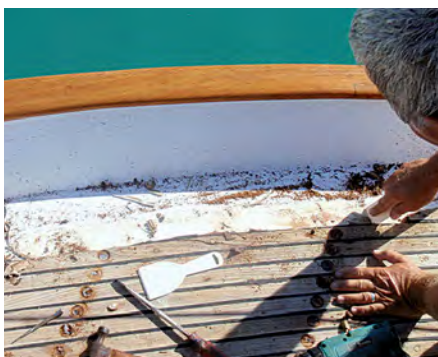
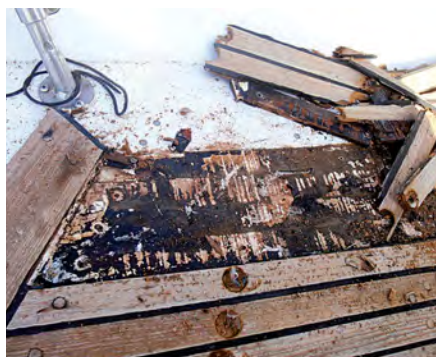
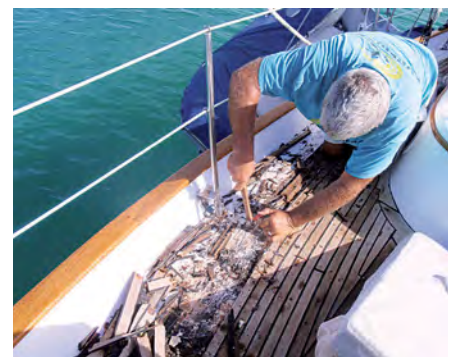
The farthest outboard teak planks were set in a white bedding compound and came up quite easily, at left. As [redacted] worked his way inboard, he found a tar-like compound that was much stickier, center. The teak from then on broke off in smaller pieces, at right.

screws securing that plank, I happily discovered that the bedding material on the outermost teak plank was the same consistency as in my test area. It was just a matter of prying up each piece with a large screwdriver. Unfortunately, as I began removing planks closer to the cabin trunk, the bedding compound changed to the dreaded tar-like material.

This goo was much stickier than the white stuff. When it came time to remove those planks, instead of popping them off nice and easy with a large screwdriver, I was forced to use a small prybar, breaking off 6- to 8-inch splinters of teak one at a time. This was, of course, much more time-consuming.

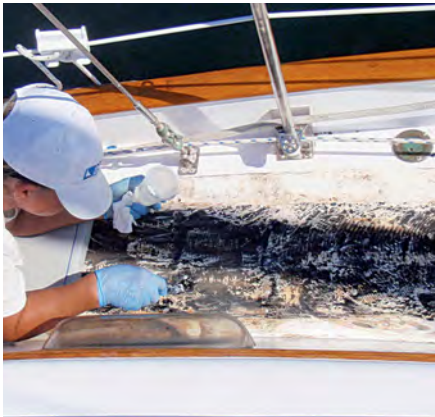
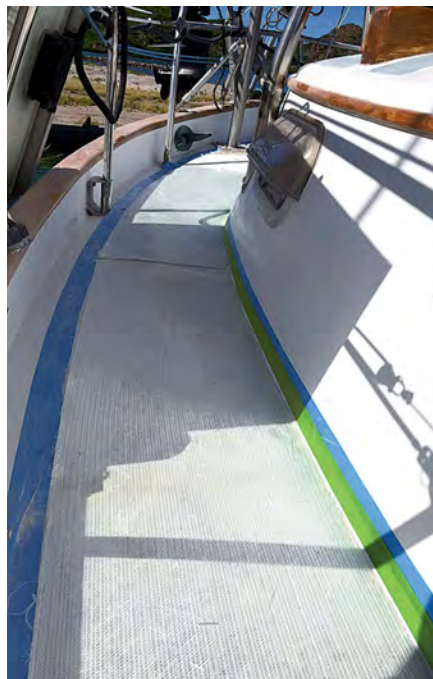
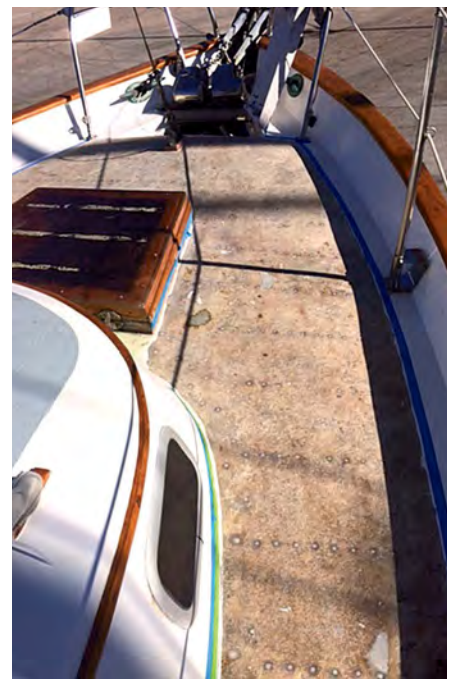
A tedious part of the project was filling the old screw holes with epoxy, above. [redacted] and [redacted] did this before power sanding the deck in preparation for the application of a layer of fiberglass cloth in epoxy resin, near right. After the epoxy had cured in the sun for a week, they sanded it fair, far right, before applying the non-skid finish.

After determining that the plywood core was sound, I drilled several holes through the fiberglass skin at the perimeter of an affected area as well as in the middle. I then injected West System epoxy into the holes, making sure the liquid traveled under the fiberglass and out of adjacent holes. When I was sure all of an area had resin in the void, I placed waxed paper over the 1-foot area and used bags filled with beach sand to hold the outer skin against the core until the epoxy cured.

newly-exposed surface with a layer of resin and fiberglass cloth. And even though there didn't seem to be an oil-canning problem, I liked the idea of adding a little more stiffness to the deck. I borrowed a small generator and an orbital sander and went about preparing the surface for fiberglass, removing the last of the bedding material as well as roughing up the old surface to get the best adhesion possible. While I sanded with 60-grit pads, I sucked up the dust and grit with our small shop vac.

We carefully cut the cloth into sections that would cover as large an area as would be manageable in the heat of the morning. We would have only about a three-hour window each day to fiberglass. Our procedure was to clean with acetone the area on which we would be working, dispense the epoxy using the metering pumps, mix a batch, wet-out the deck, and lay down the cloth while using chip brushes to saturate it thoroughly with epoxy. We used a plastic squeegee to smooth the cloth and remove excess resin.

By the time we got to the somewhat expansive foredeck, we had more confidence in our ability to do larger areas. After three days of this, the cloth was successfully laminated to the deck. We let the Mexican sun bake the whole works for a week before I broke out the orbital sander and tackled the seams and edges of the newly applied surface. I knocked down the highest of the bumps with 60-grit sanding discs, then switched to 120-grit pads for the final sanding. We planned to apply non-skid, and the 120-grit gave the surface a tooth for it to adhere to.

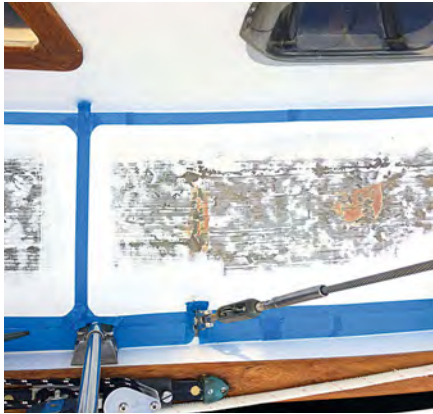
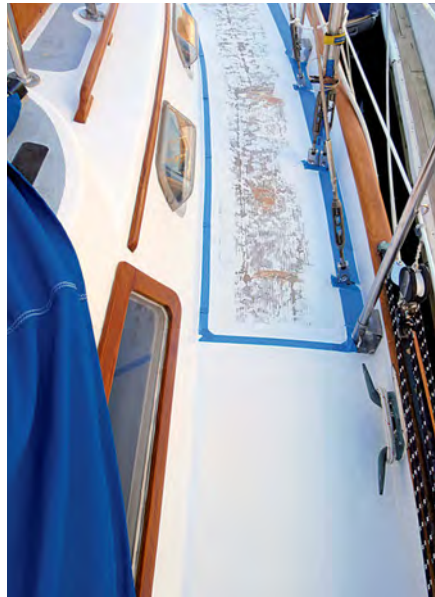
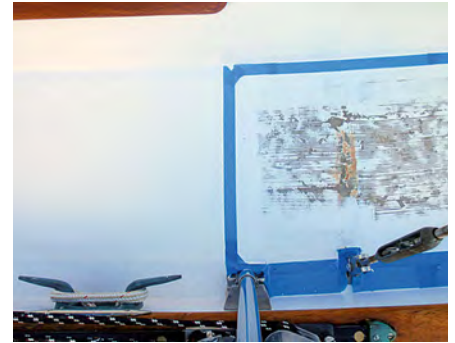
[redacted] painted borders and detail strips with gloss enamel. Taped over for protection, far left, the borders defined areas that could be coated with non-skid in a reasonable time, at left and above.

as possible, we broke up the non-skid coating with bordering "detail strips." These would be painted surfaces, about an inch wide, along the inside of the deck next to the cabin, and a wider strip along the outboard edge of the deck, adjacent to the bulwarks. We also painted 1-inch detail strips across the sidedeck at three places on each side of the boat, from the cabin sides to the bulwarks.

We took special care in prepping the smooth areas because the white gloss paint would reveal any imperfections. Once we'd sanded and filled and sanded again, we applied two coats of Brightside to an area an inch wider than the finished detail strip would be. We let this paint dry for a week before masking the newly-painted surface prior to applying the KiwiGrip.

As advertised, the KiwiGrip went on easily, dried within hours, cleaned up with water, and looks great. We chose an aggressive finish that would feel secure underfoot, even with the decks awash.

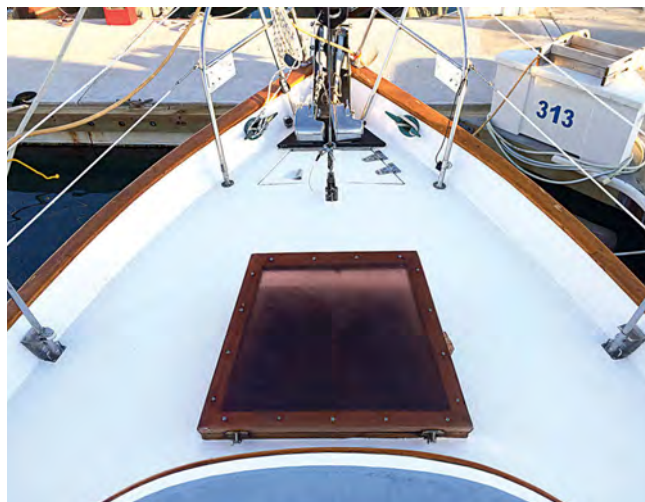
While the look is very different from teak, the result of [redacted] and [redacted] labors is a clean-looking, light-colored deck that reflects heat, is comfortable to walk on, and will be easy to maintain.
